NAUGATUCK RIVER BASIN
NAUGATUCK, CONNECTICUT

**THURSTON POND DAM
CT 00129**

**PHASE I INSPECTION REPORT
NATIONAL DAM INSPECTION PROGRAM**

DECEMBER 1980

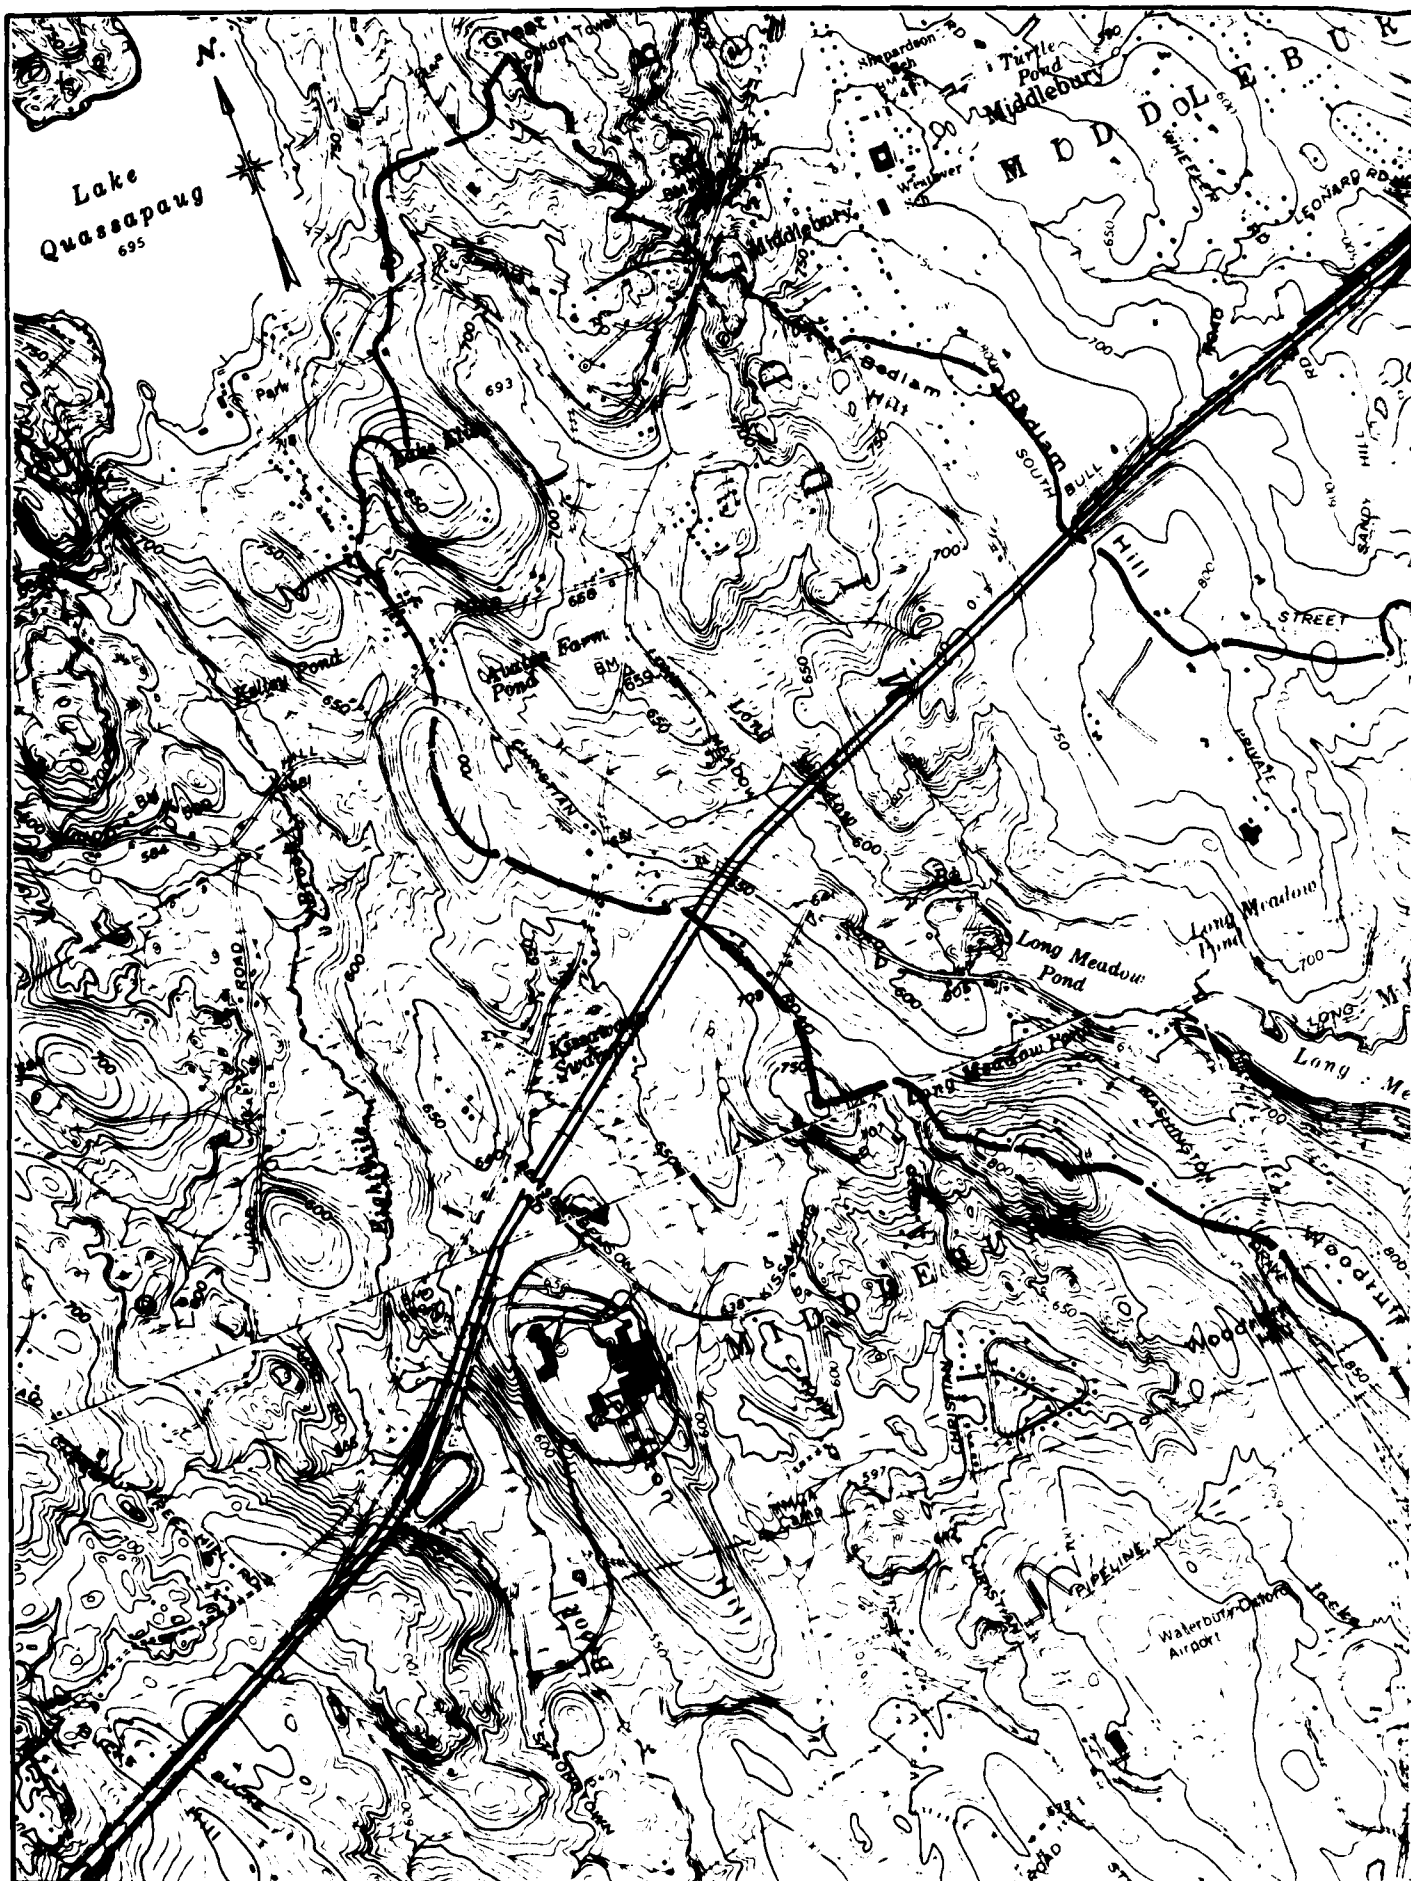
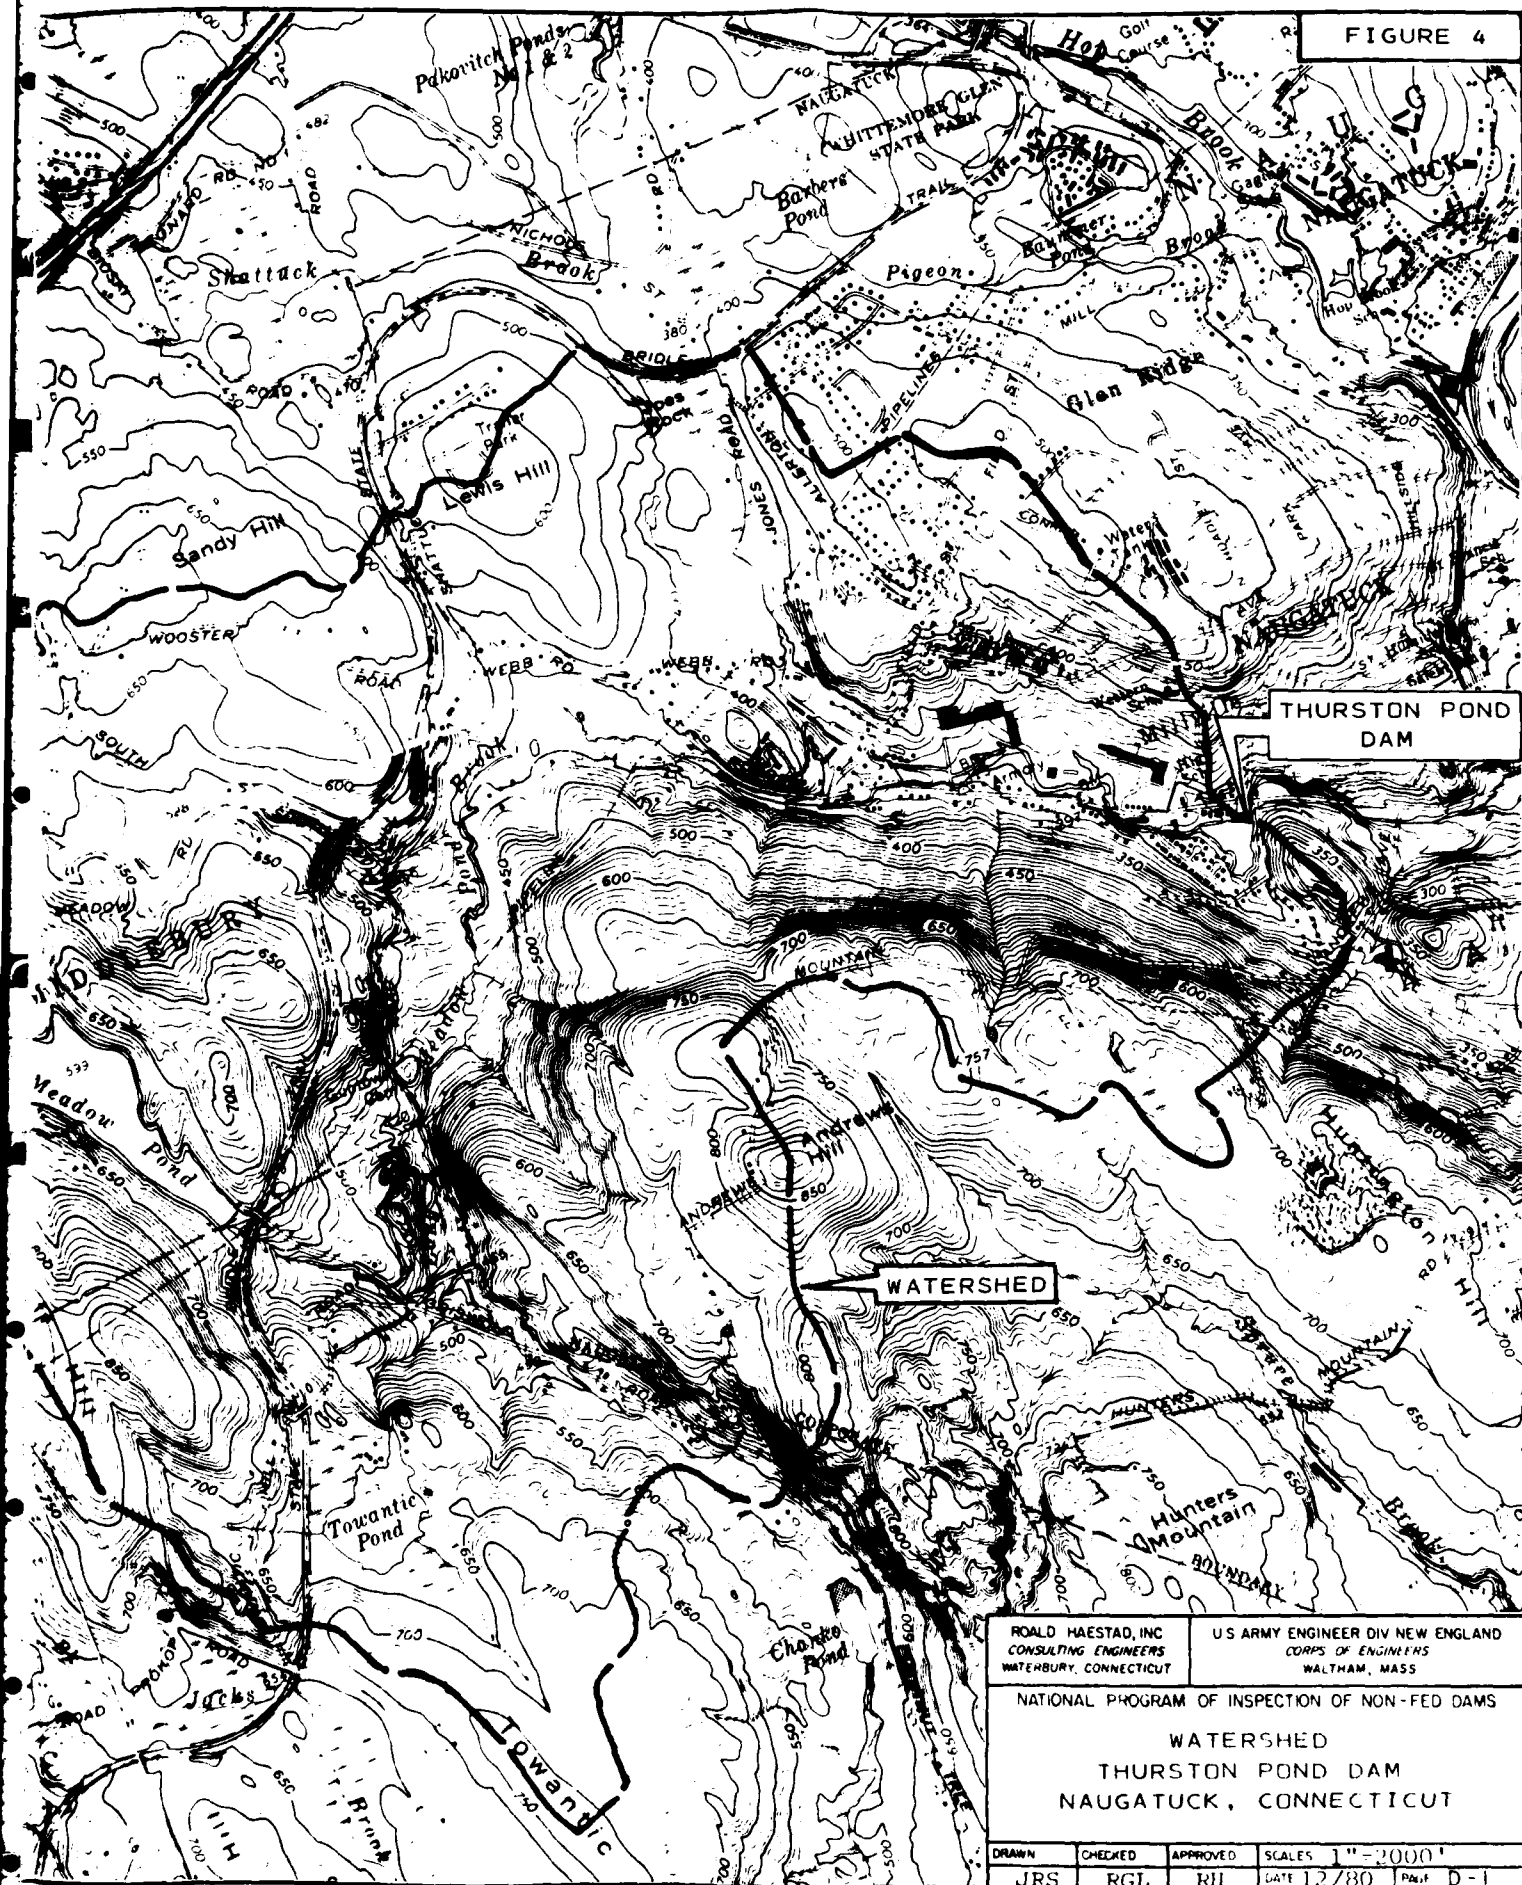
FIGURE 4

The tributary watershed area is 7.8 square miles of "rolling" wooded hills with scattered residential development, except for the section along Rubber Avenue within one mile of the dam which has substantial commercial development. The watershed elevations range from 970 feet at the northwest end to 275 feet at the dam. There are several ponds within the watershed, but only Long Meadow Pond is of significant size (Figure 4, page D-1).

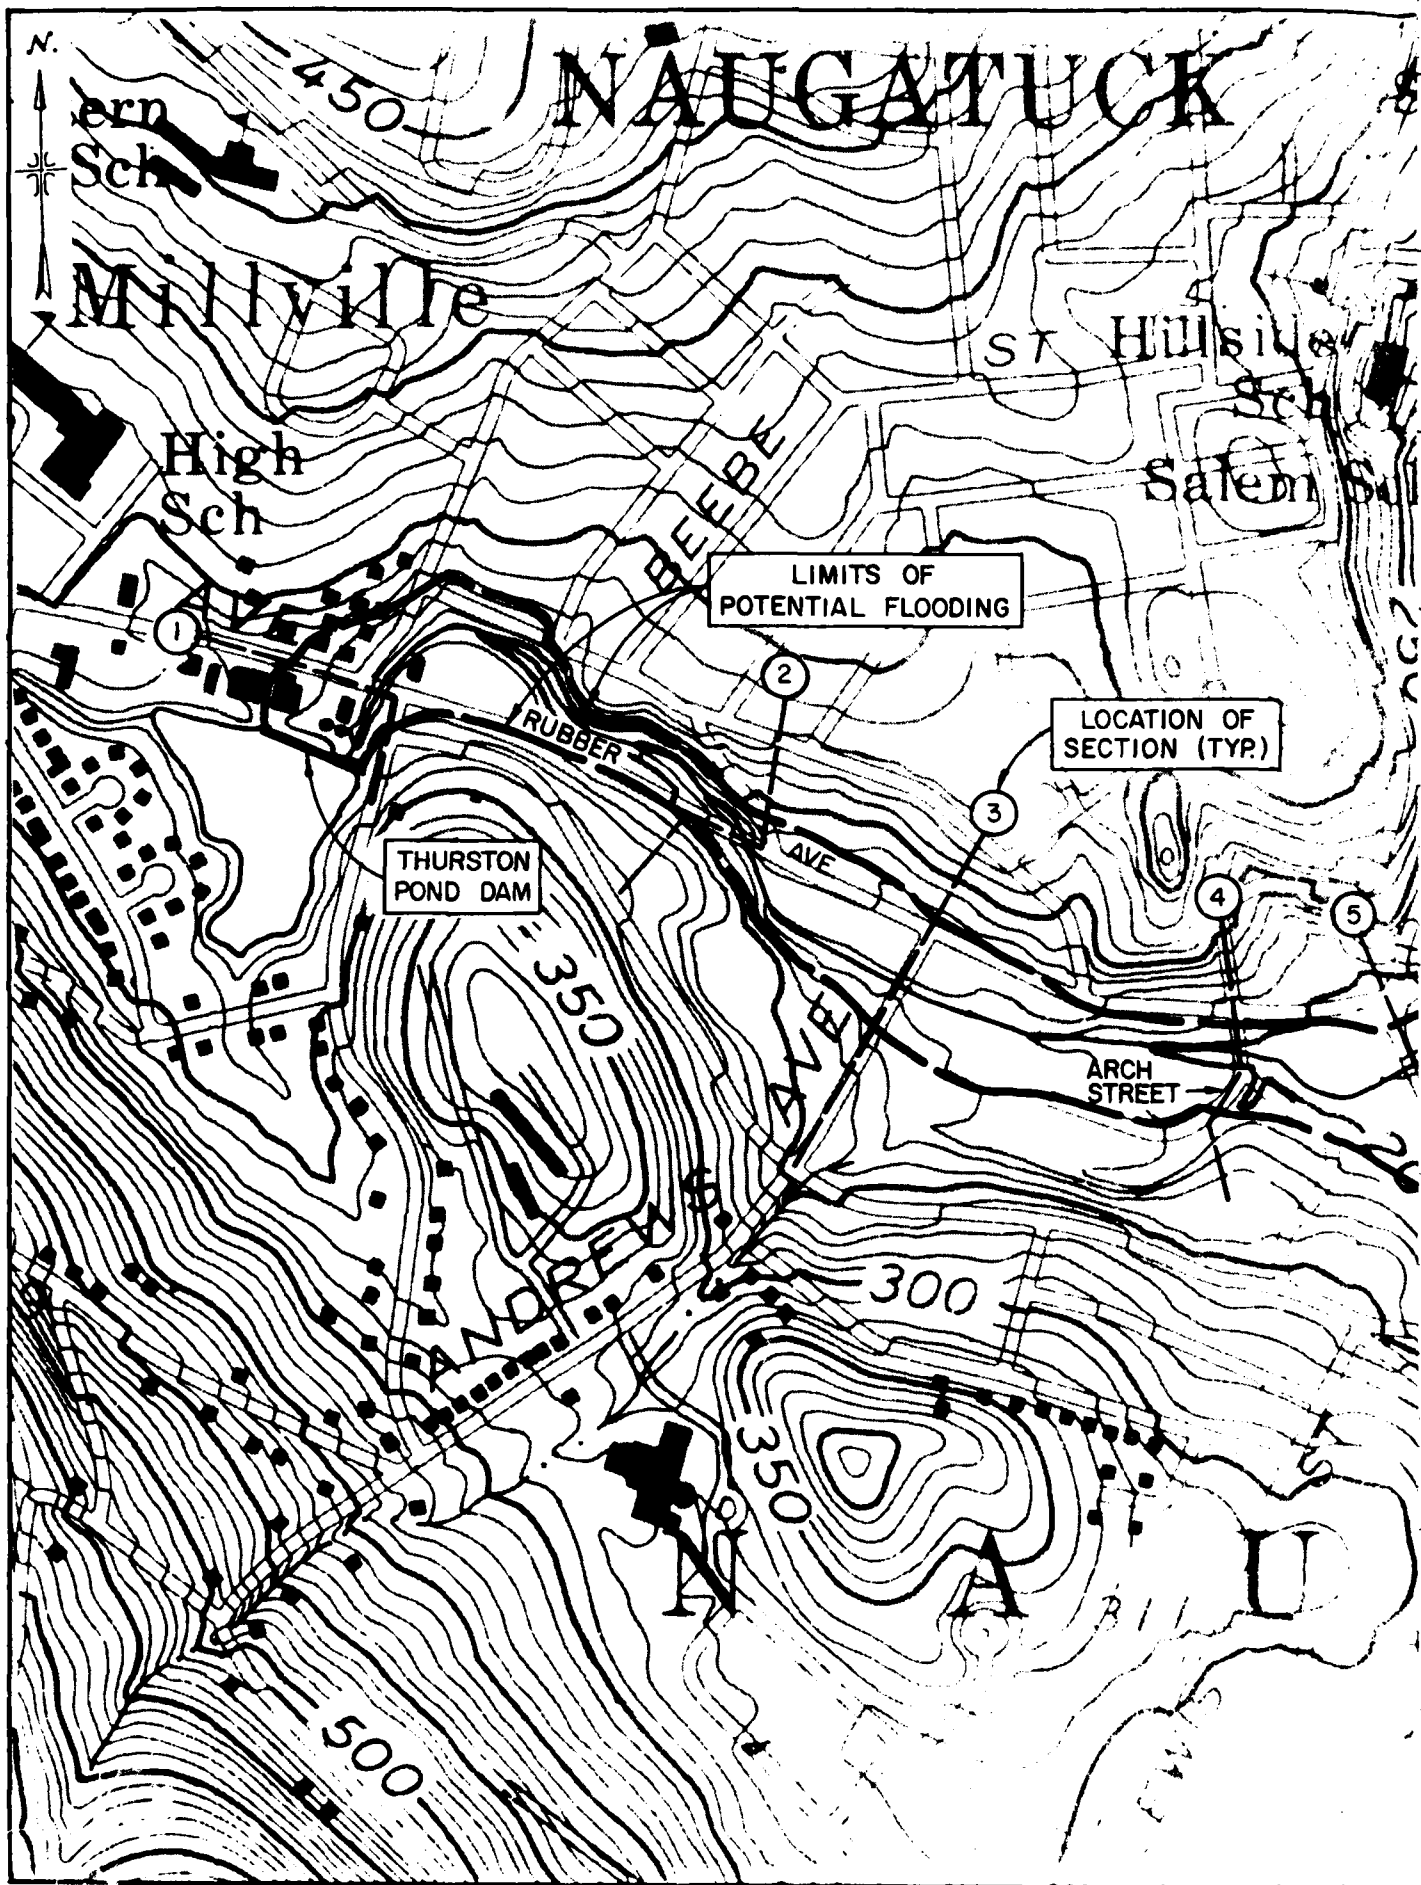
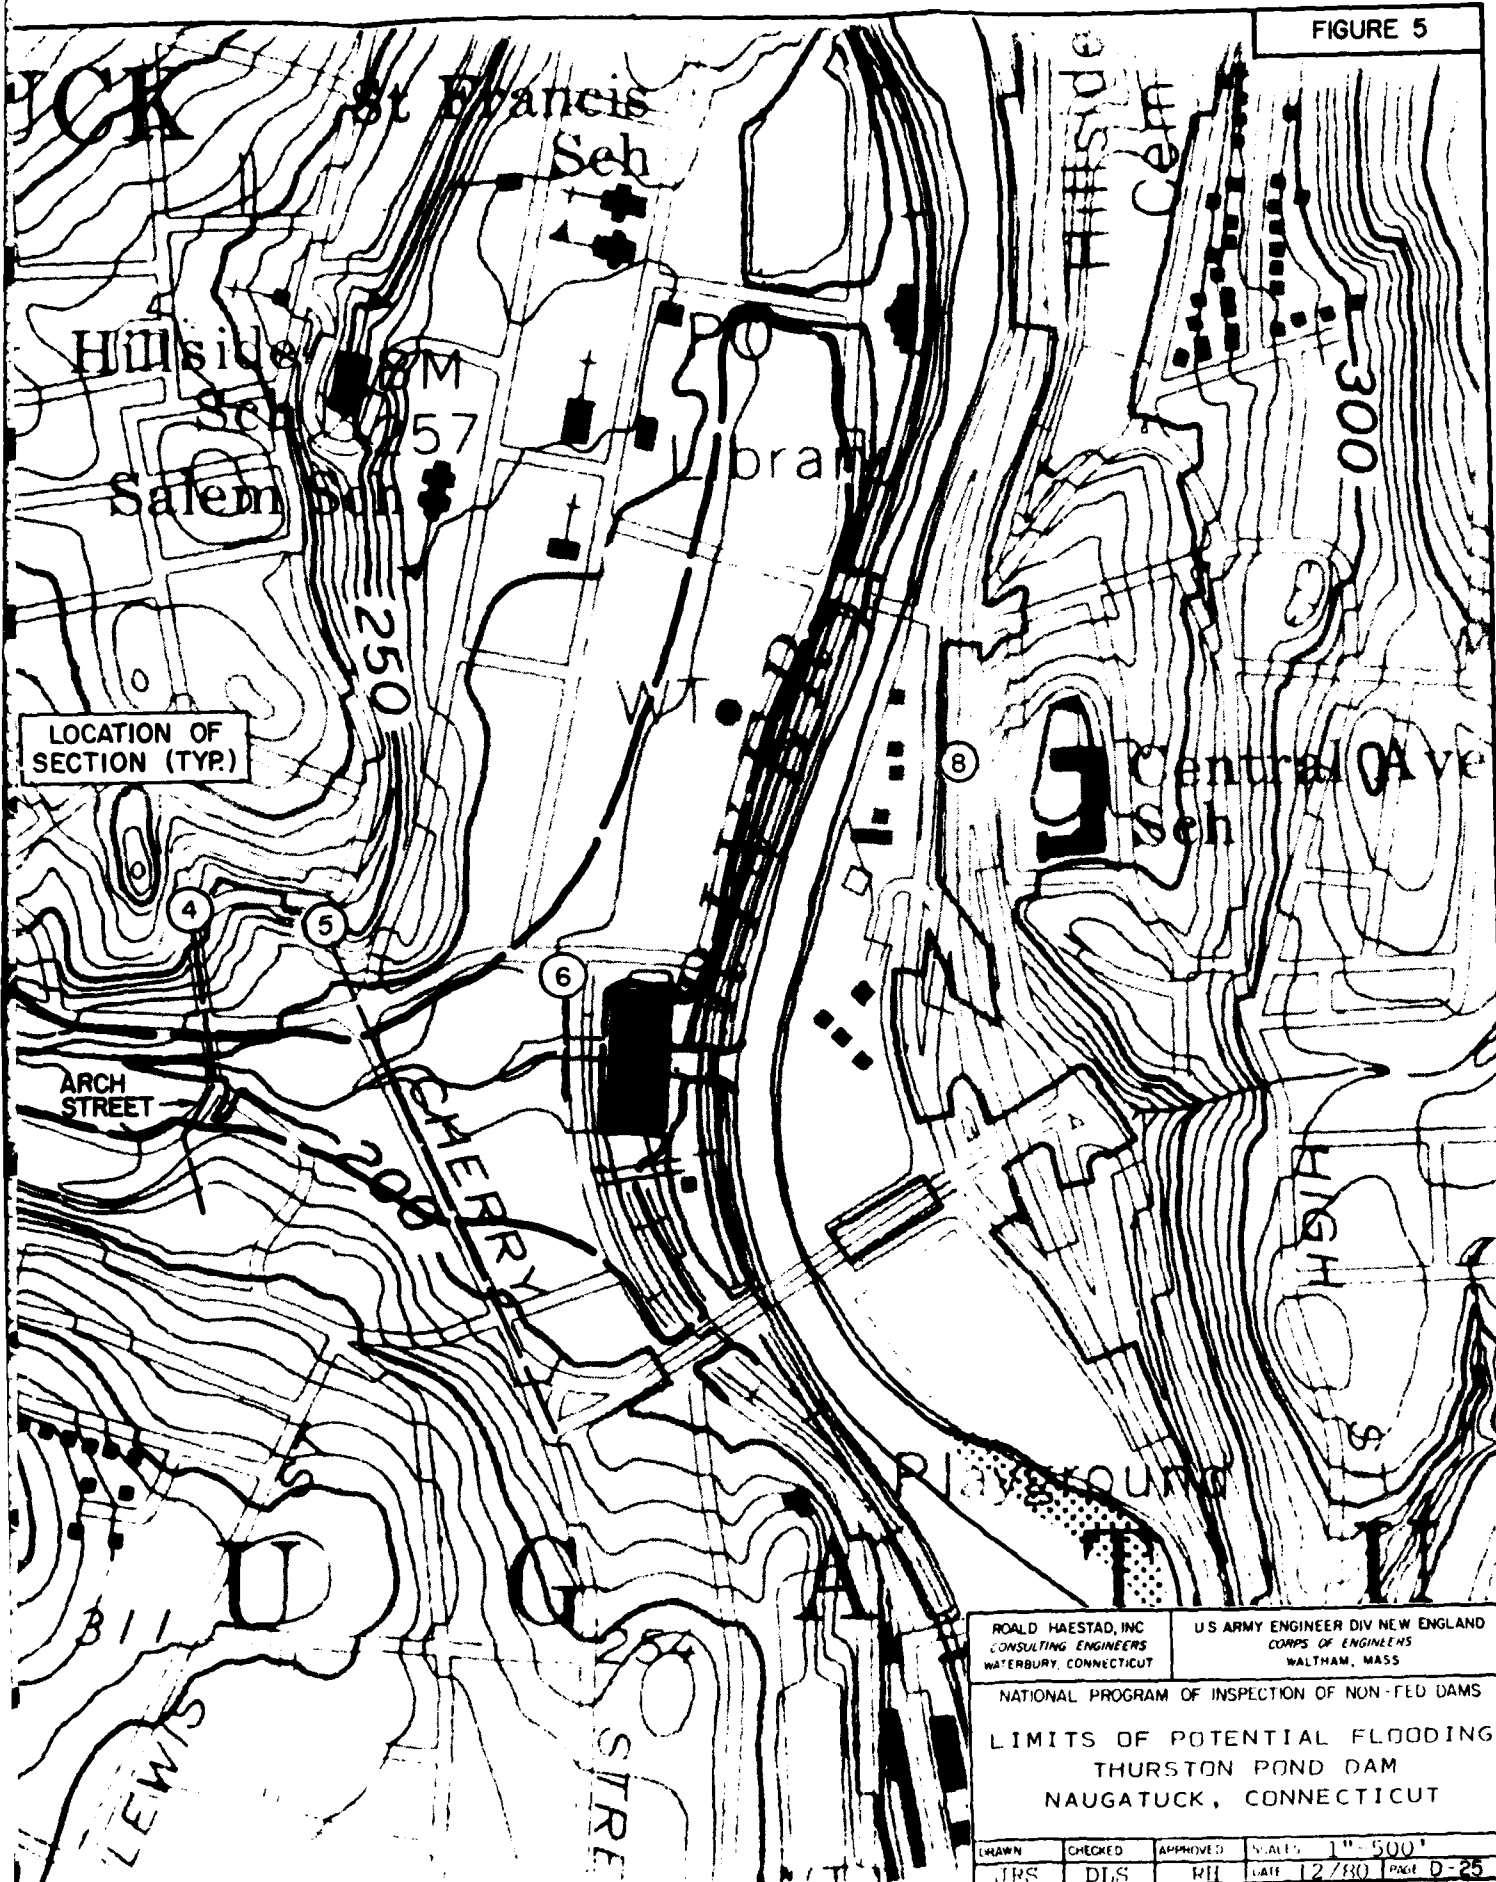
FIGURE 5

Based on the Corps of Engineers' Recommended Guidelines for Safety Inspection of Dams, the hazard classification for the dam is "High". A dam failure could result in the loss of more than a few lives and extensive property damage. A dam failure analysis indicates that a breach of Thurston Pond Dam would overtop Rubber Avenue by approximately 8 feet, flooding commercial structures to a depth of approximately 6 feet above floor level. The flood waters would continue downstream, overtopping several streets by up to 7 feet. Downstream of Andrew Avenue and Cherry Street industrial complexes would be flooded by up to 3 feet (see Figure 5, page D-25).

The peak outflow at Cherry Street Section 5 (see Figure 5, page D-25) is approximately 6,500 cfs. Downstream of Cherry Street the stream flows within 2 arched corrugated metal pipe culverts beneath a large industrial complex. The peak capacity of the 2 culverts is approximately 3,200 cfs. The flood waters would overtop the channel banks and flow overland to the Naugatuck River, flooding the industrial complex.
